**V MECH
ROTTEC**

AXIAL SPLIT DOUBLE SUCTION PUMP – COMPLETE OVERHAUL & RECONDITIONING

Axial Split Double Suction Pump
Cooling Water Service

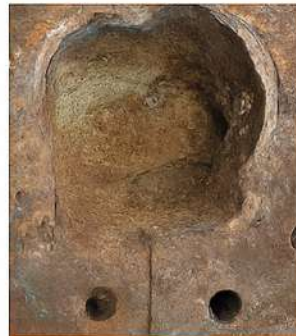
BEFORE

- Severe corrosion on internal surfaces
- Erosion and pitting damage on casing
- Worn-out sealing areas and rusted bolting
- Loss of hydraulic efficiency

1. Dismantling and inspection of all components.
2. Grit blasting and removal of corrosion.
3. Surface rebuilding using high-performance metal-filled epoxy.
4. Precision machining and dimensional restoration.
5. Application of anti-corrosive & hydraulic smooth coating.
6. Assembly, alignment and performance check.
